The first steps to cure your Icom IC-7100 shut down problem

By Tallman

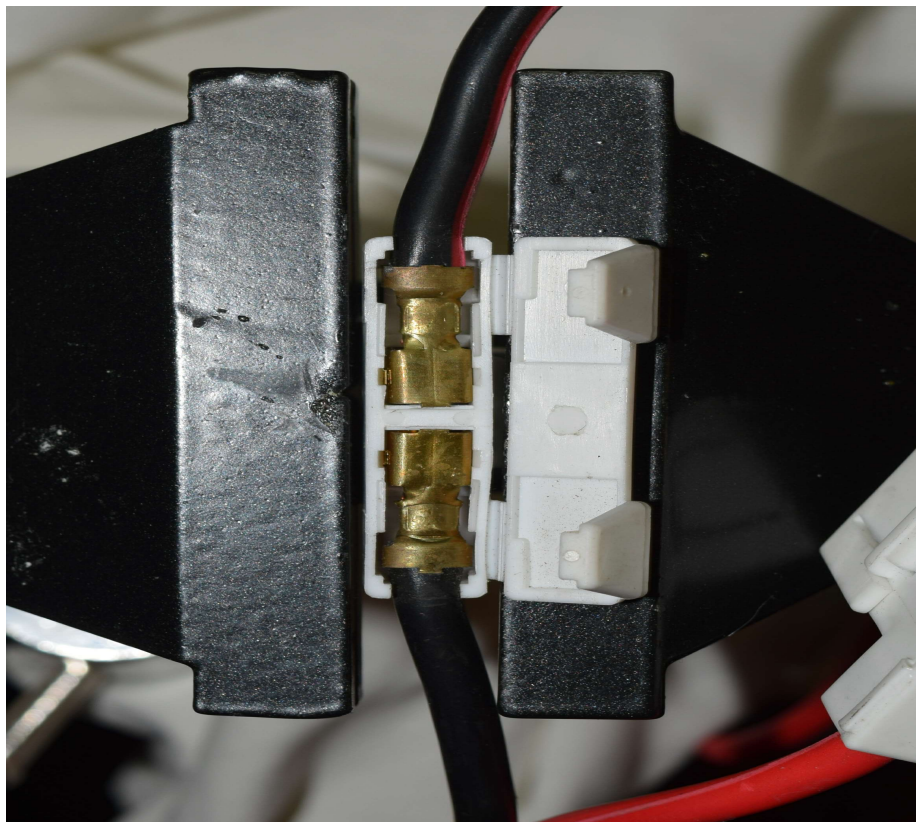
When I checked the voltage on my test bench the voltage it was dropping down to 11.3 volt and I have a 50 amp Megawatt power supply so there was plenty of current available. I was going just to fix this problem. I opened the back of the fuse holders and pried the connector clips out of case and inspected them under 20x microscope. The color did not look right and showed some indications of heating.

This indicated to me that there was a resistance between the wire and connector clip. I did not have replacement parts available and ended up soldering the existing connectors as they were. I don't like soldering wires where the solder and melting insulation will mix, but at this point I really did not have a choice. I soldered all four connectors and reassembled for more testing.
